**Santa Monica Mountains National Recreation Area  
Visitor Center, King Gillette Ranch**

**Attachment 9 – Excerpt from the  
National Register Preliminary Determination of Eligibility**

## Preliminary Determination of Eligibility

## **Stable**

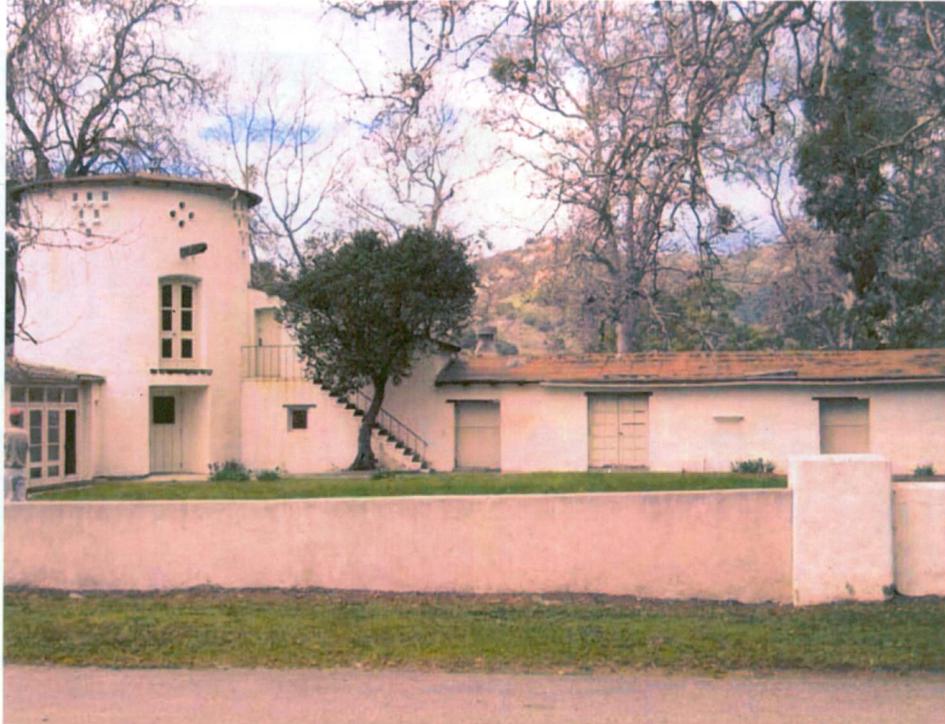
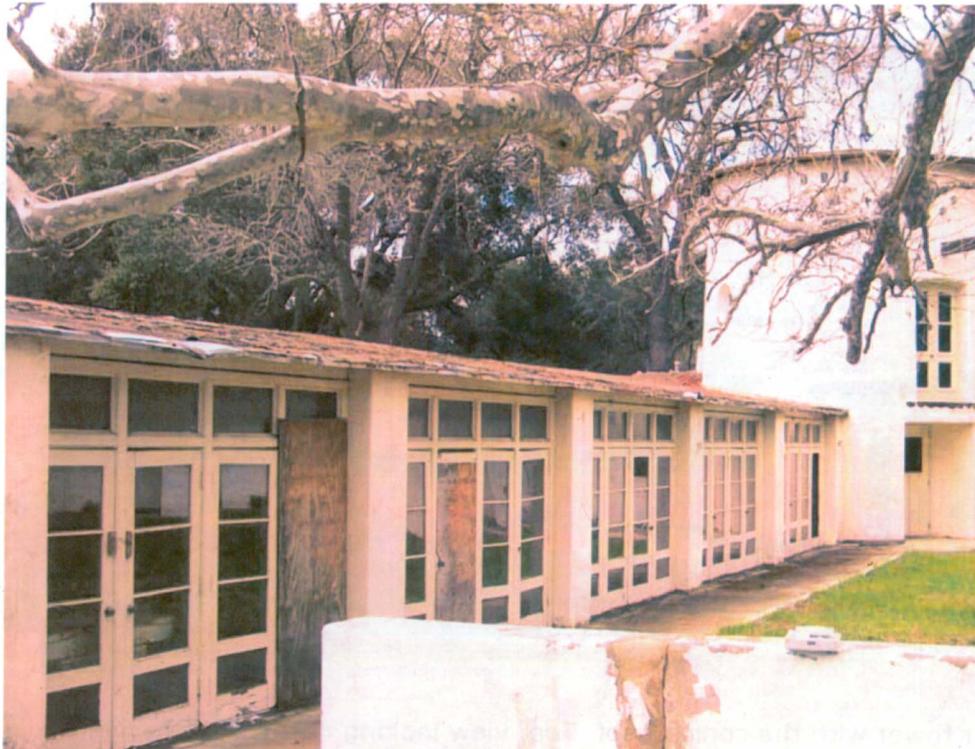
View of the enclosed yard and west wing (top) and south wing (bottom). (April, 2006)

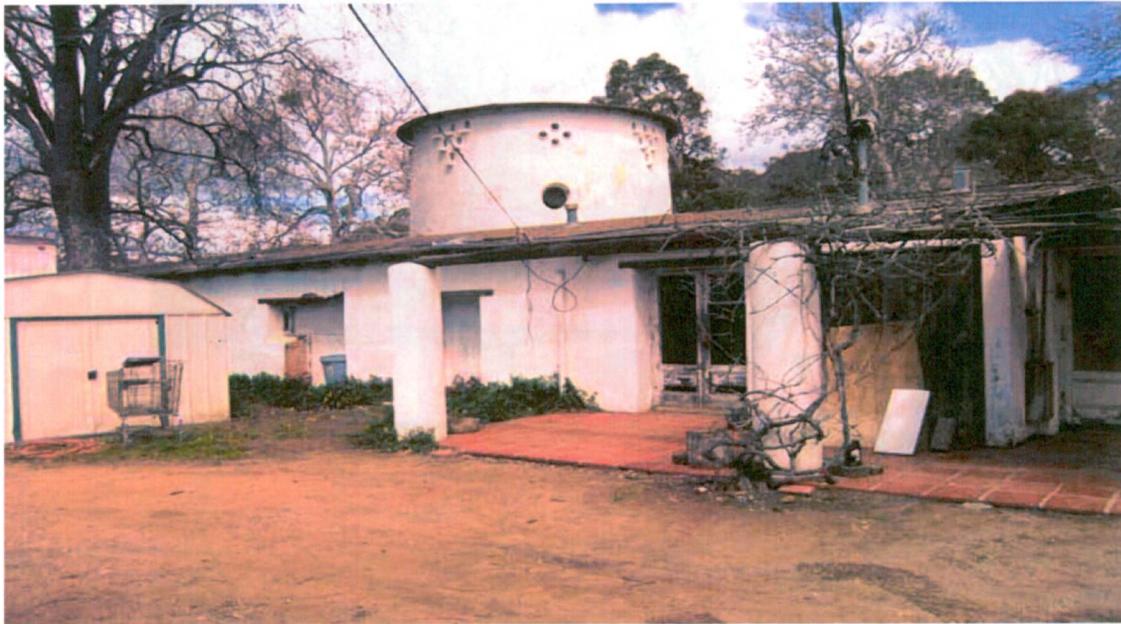
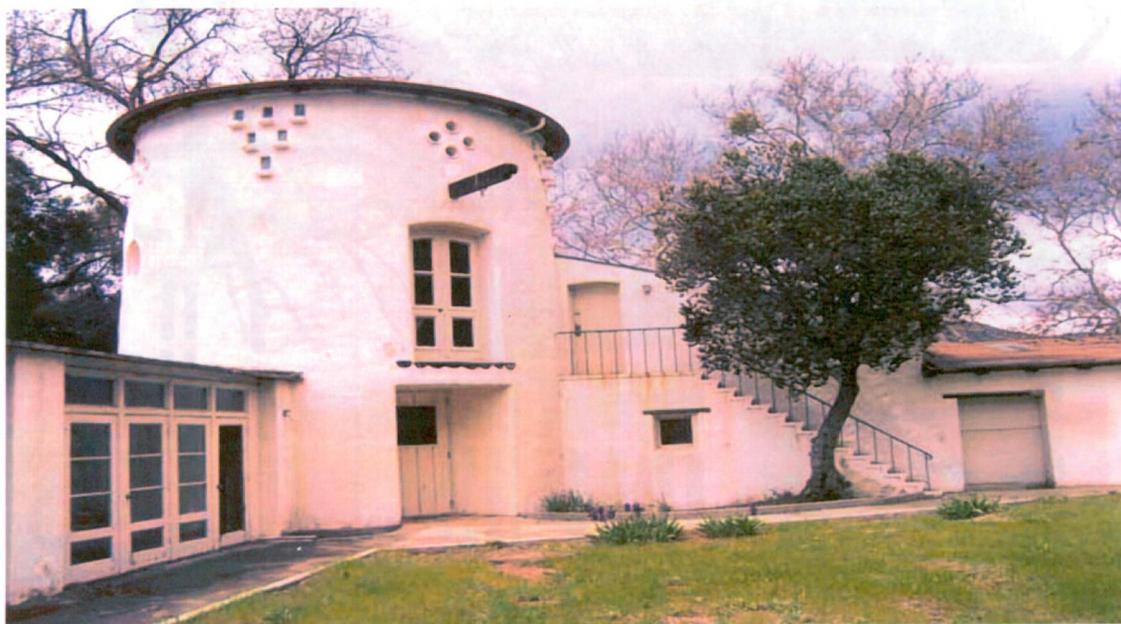
Center tower with the conical roof. Top, view looking north. Bottom, view looking west. (April, 2006)

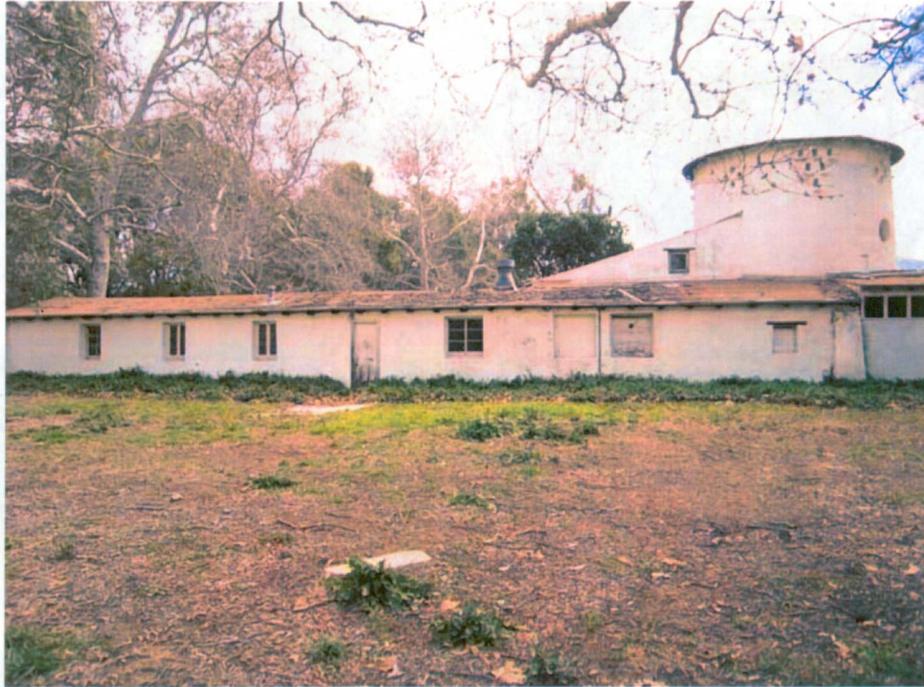
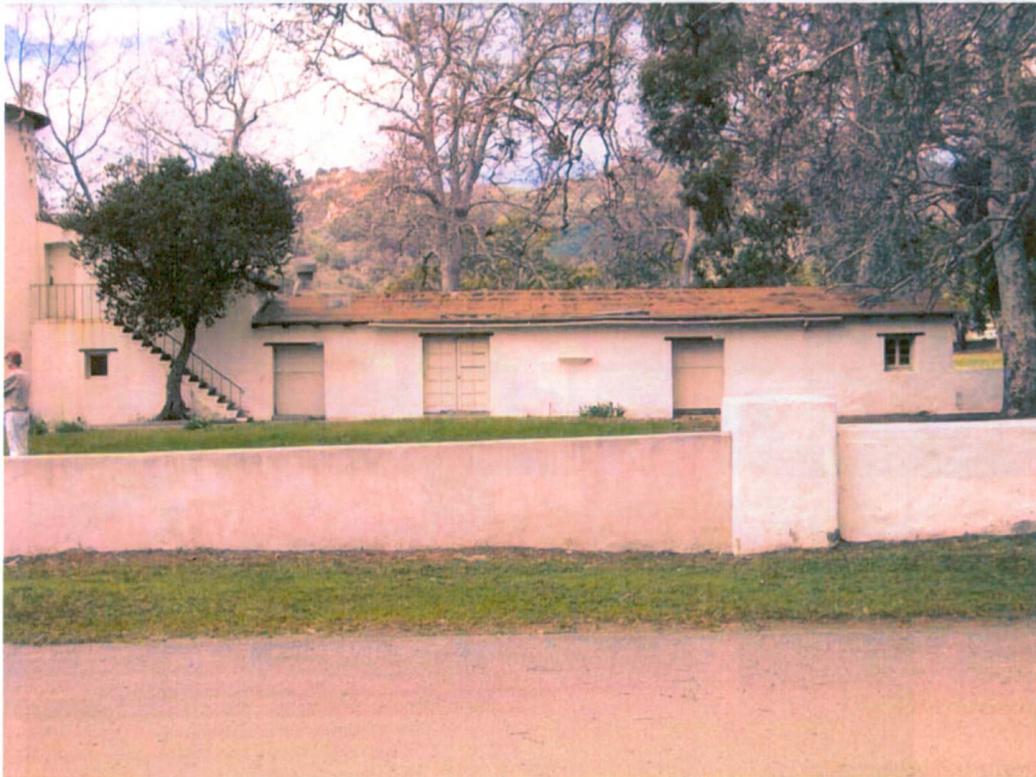
Top: View of one story north wing looking east. Bottom: view looking west.  
(April, 2006)

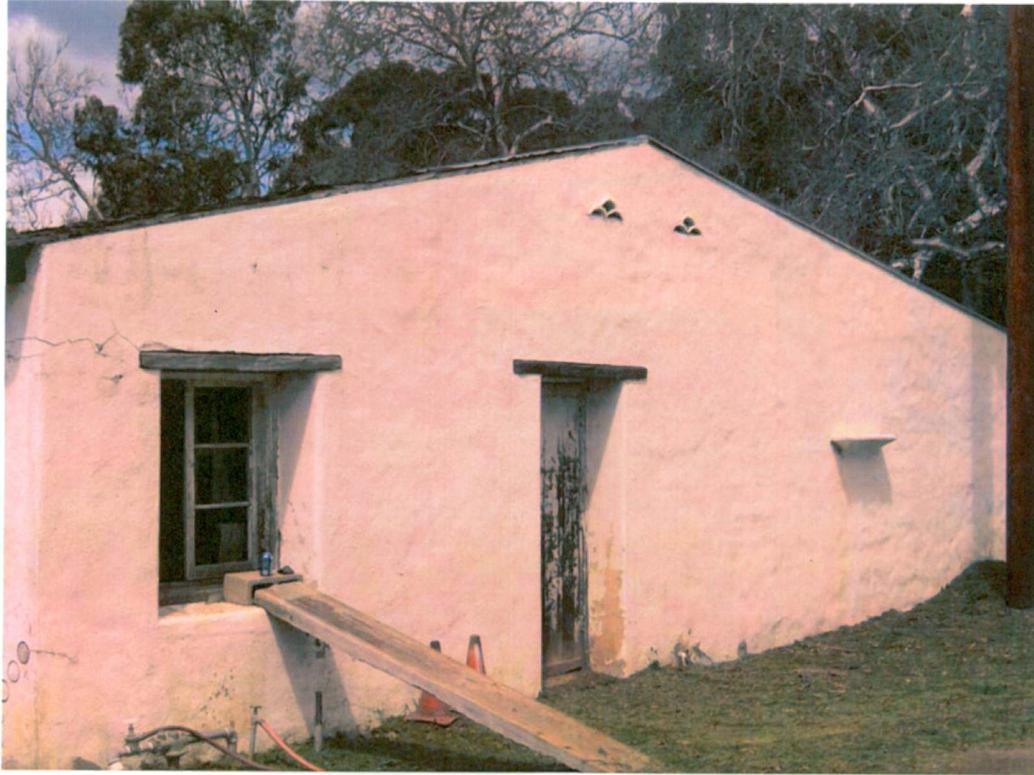
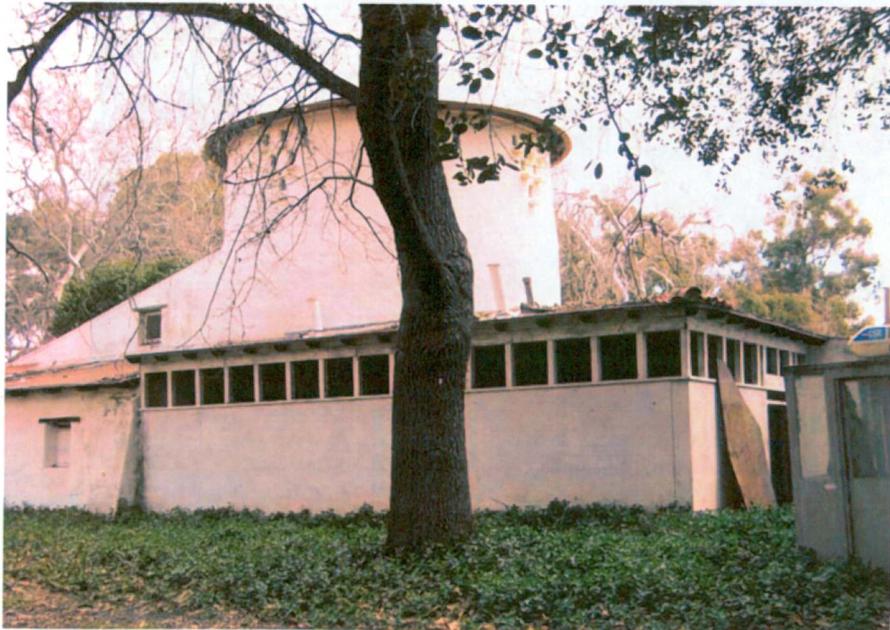
Area behind (south of) the tower. (April, 2006)

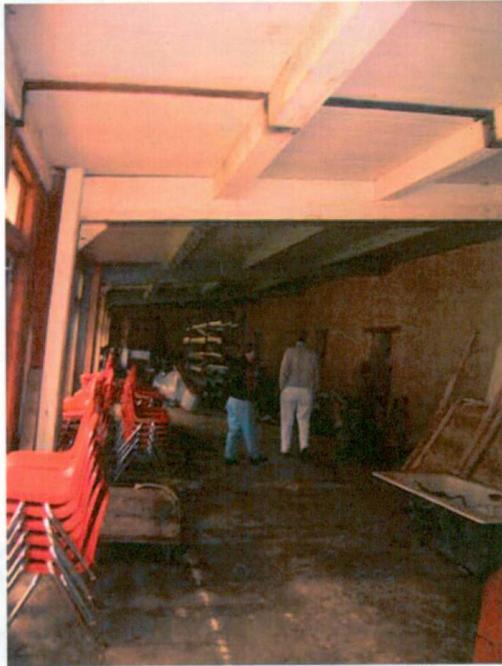
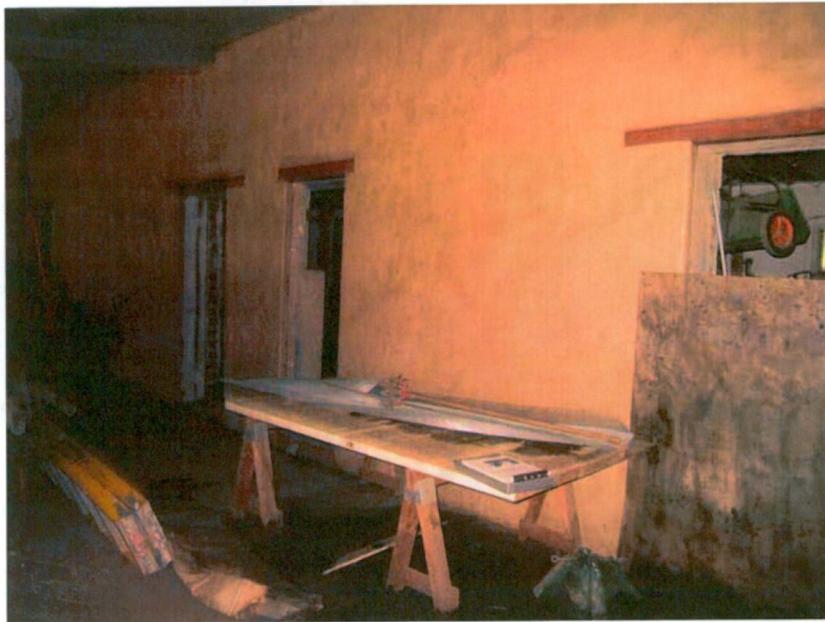
Stable interior. (April, 2006)

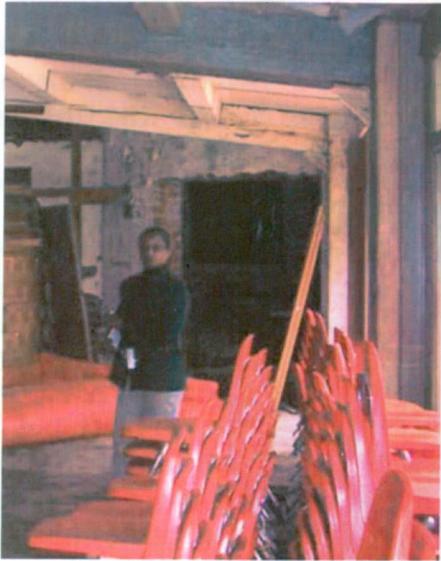
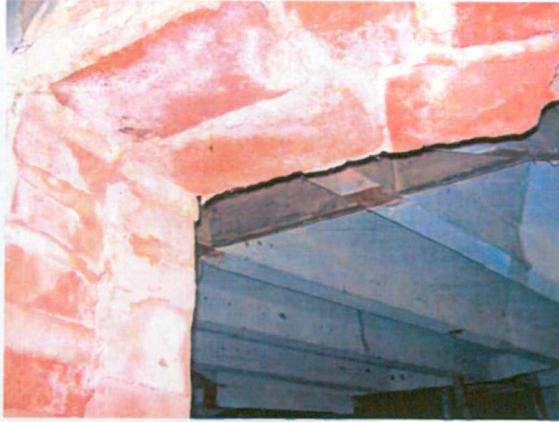
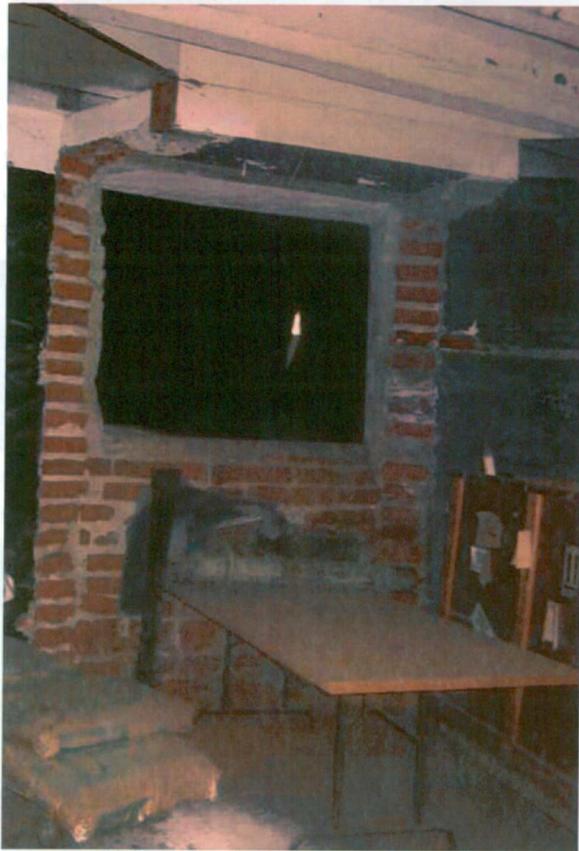
Stable interior. (April, 2006)

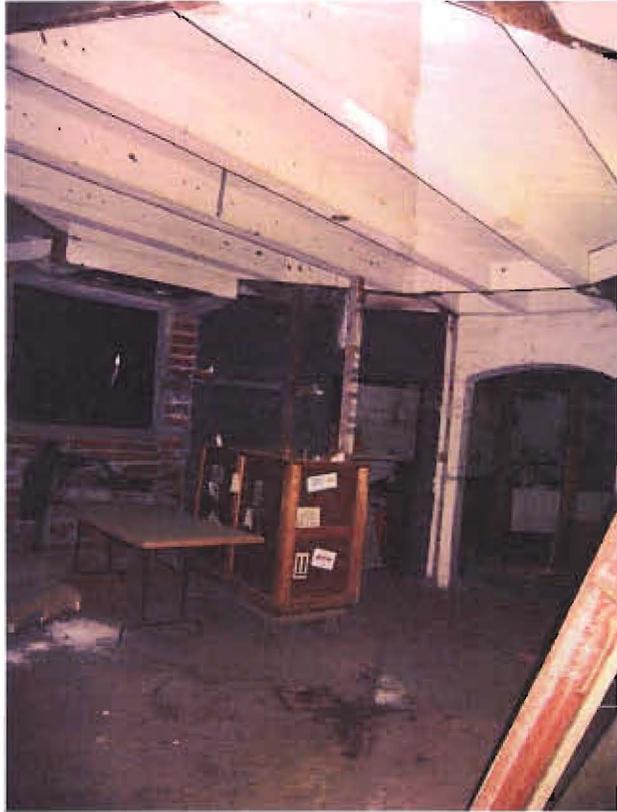
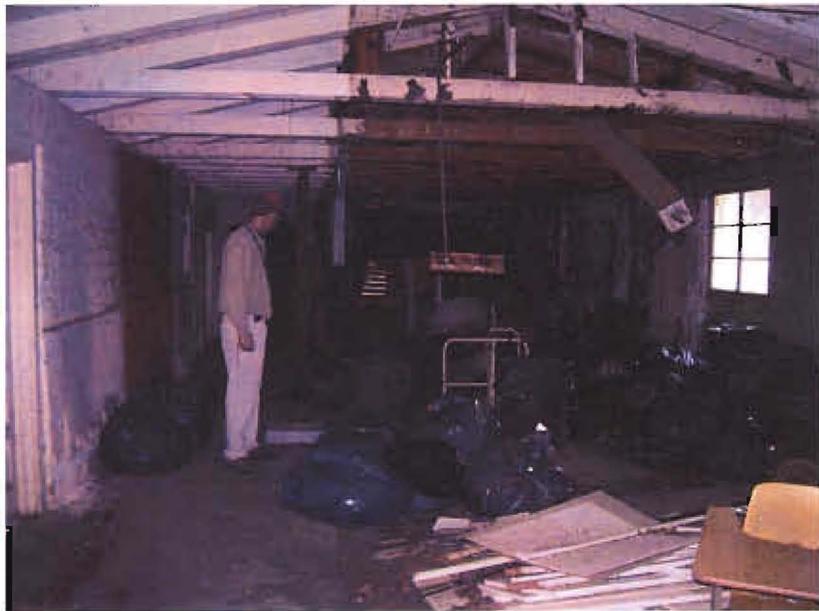
Stable interior. (April, 2006)
