**MALIBU PARKS PUBLIC ACCESS ENHANCEMENT
NATIVE TREE PROTECTION PLAN
Modified Redesign Plan**

DUDEK

AUGUST 2010

**Malibu Parks Public Access Enhancement
Native Tree Protection Plan
Modified Redesign Plan**

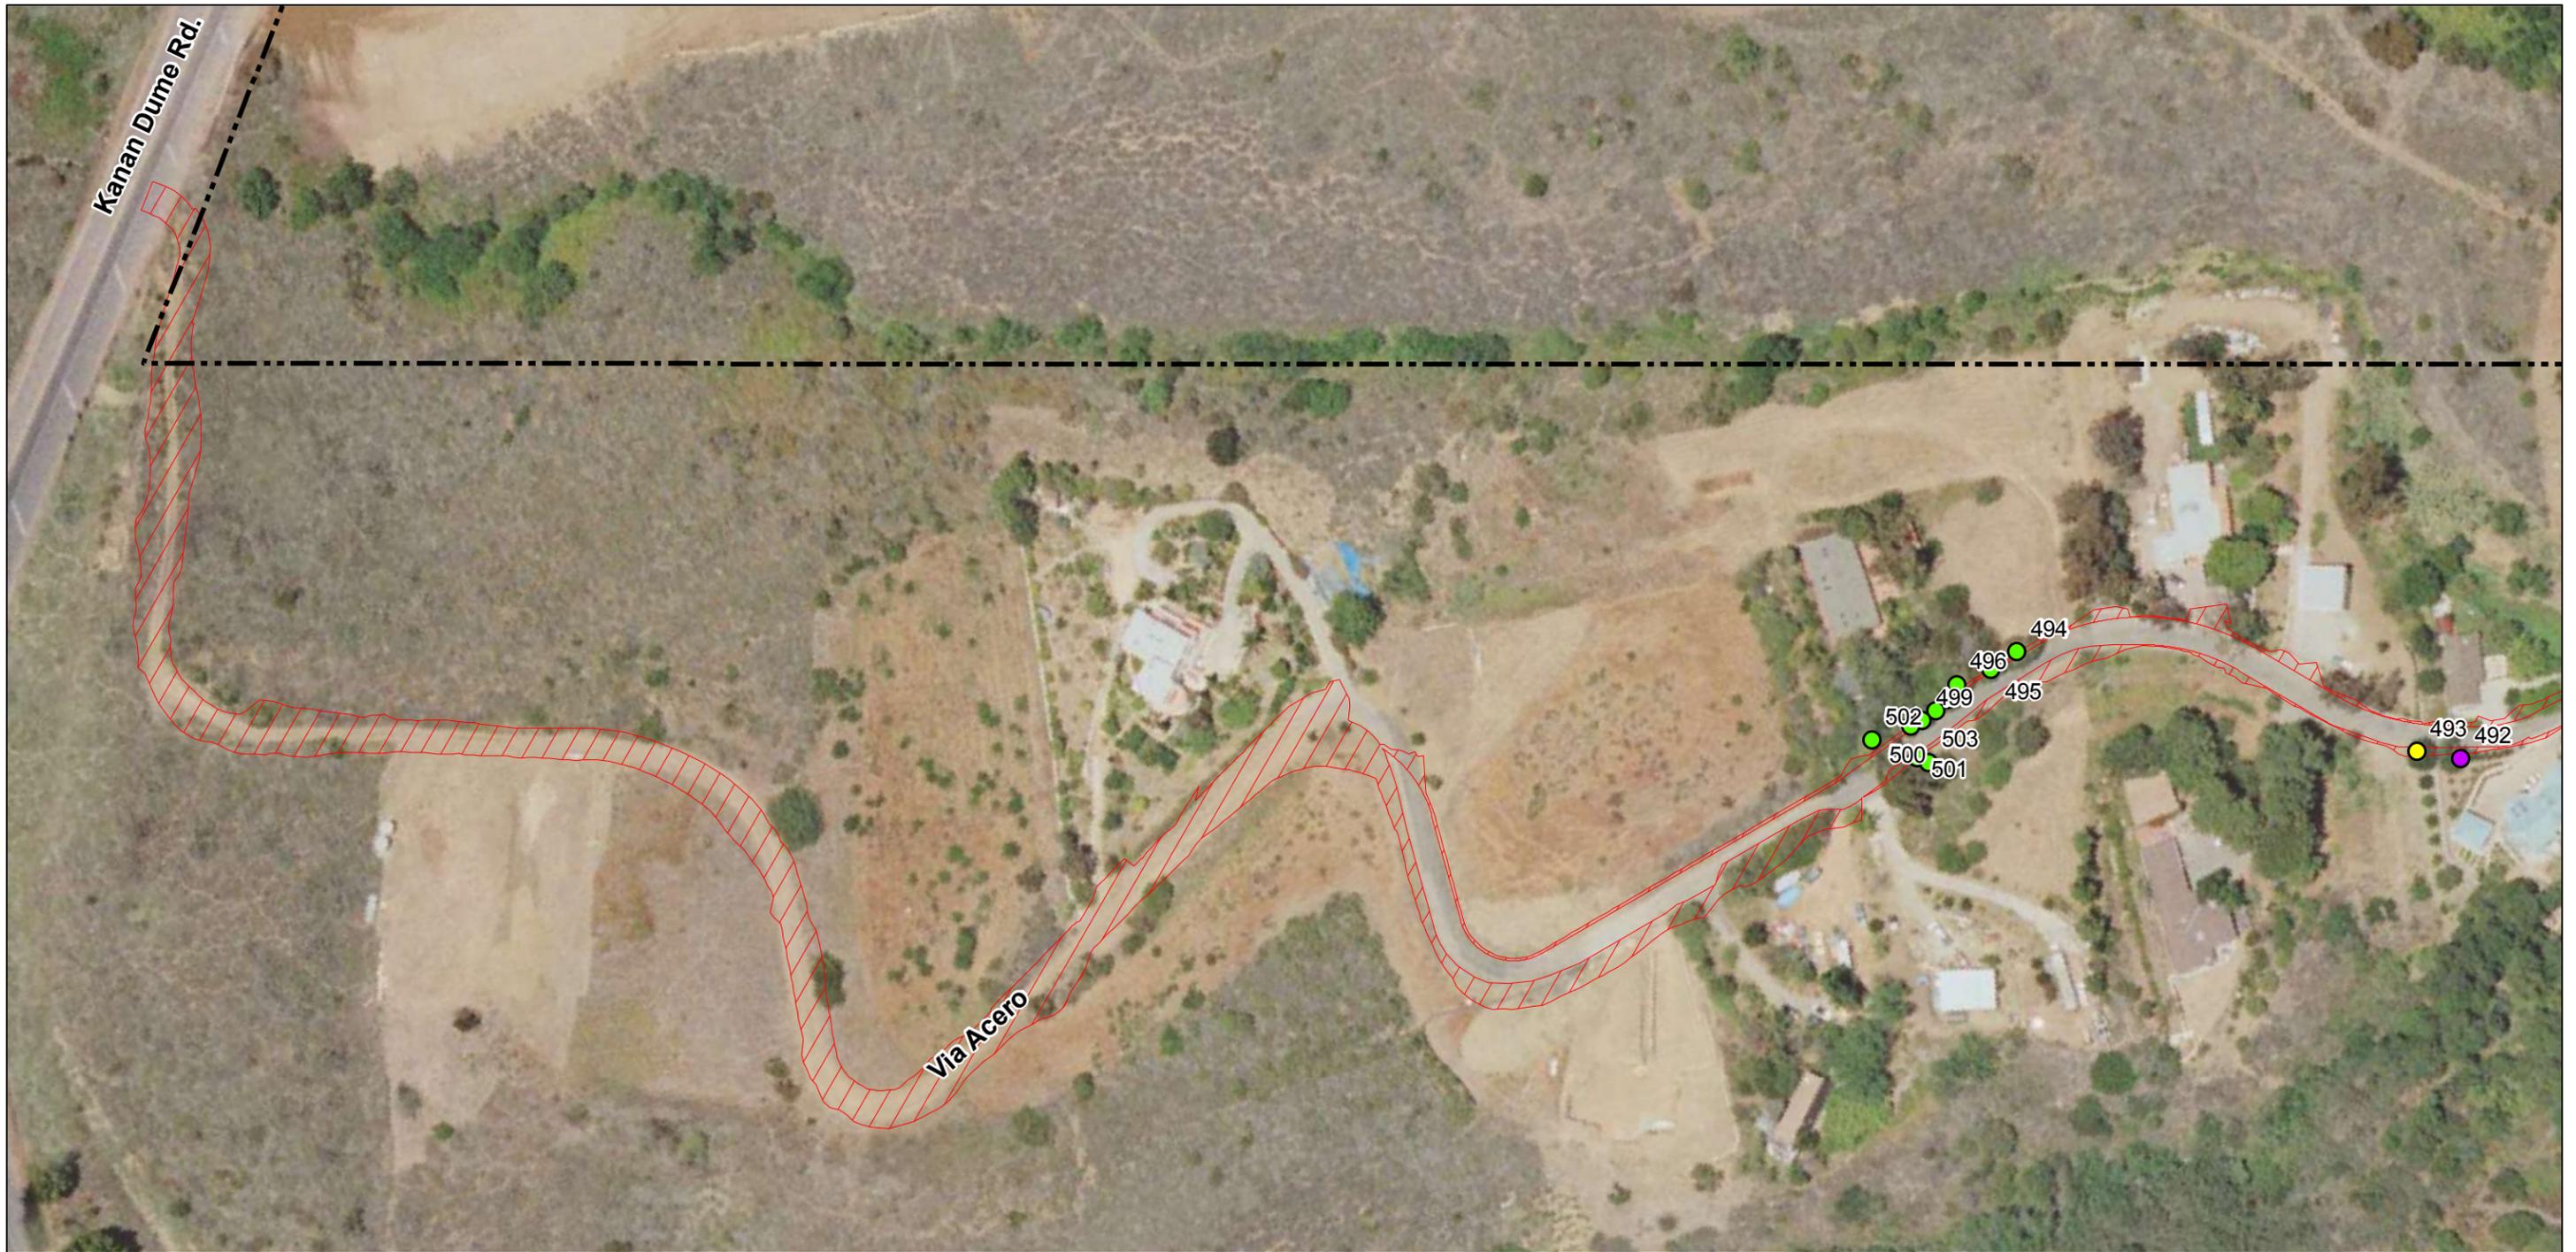
FIGURE A-1
Tree Location Exhibit - Via Acero

- Non-Native Trees
- Coast live oak (*Quercus agrifolia*)
- Western sycamore (*Platanus racemosa*)
