ESCONDIDO
CANYON
TRAIL

**BURNED AND BULKED
ESCONDIDO CANYON
CREEK CROSSING
SANTA MONICA MOUNTAINS
MALIBU, CALIFORNIA**

EXHIBIT BB-2

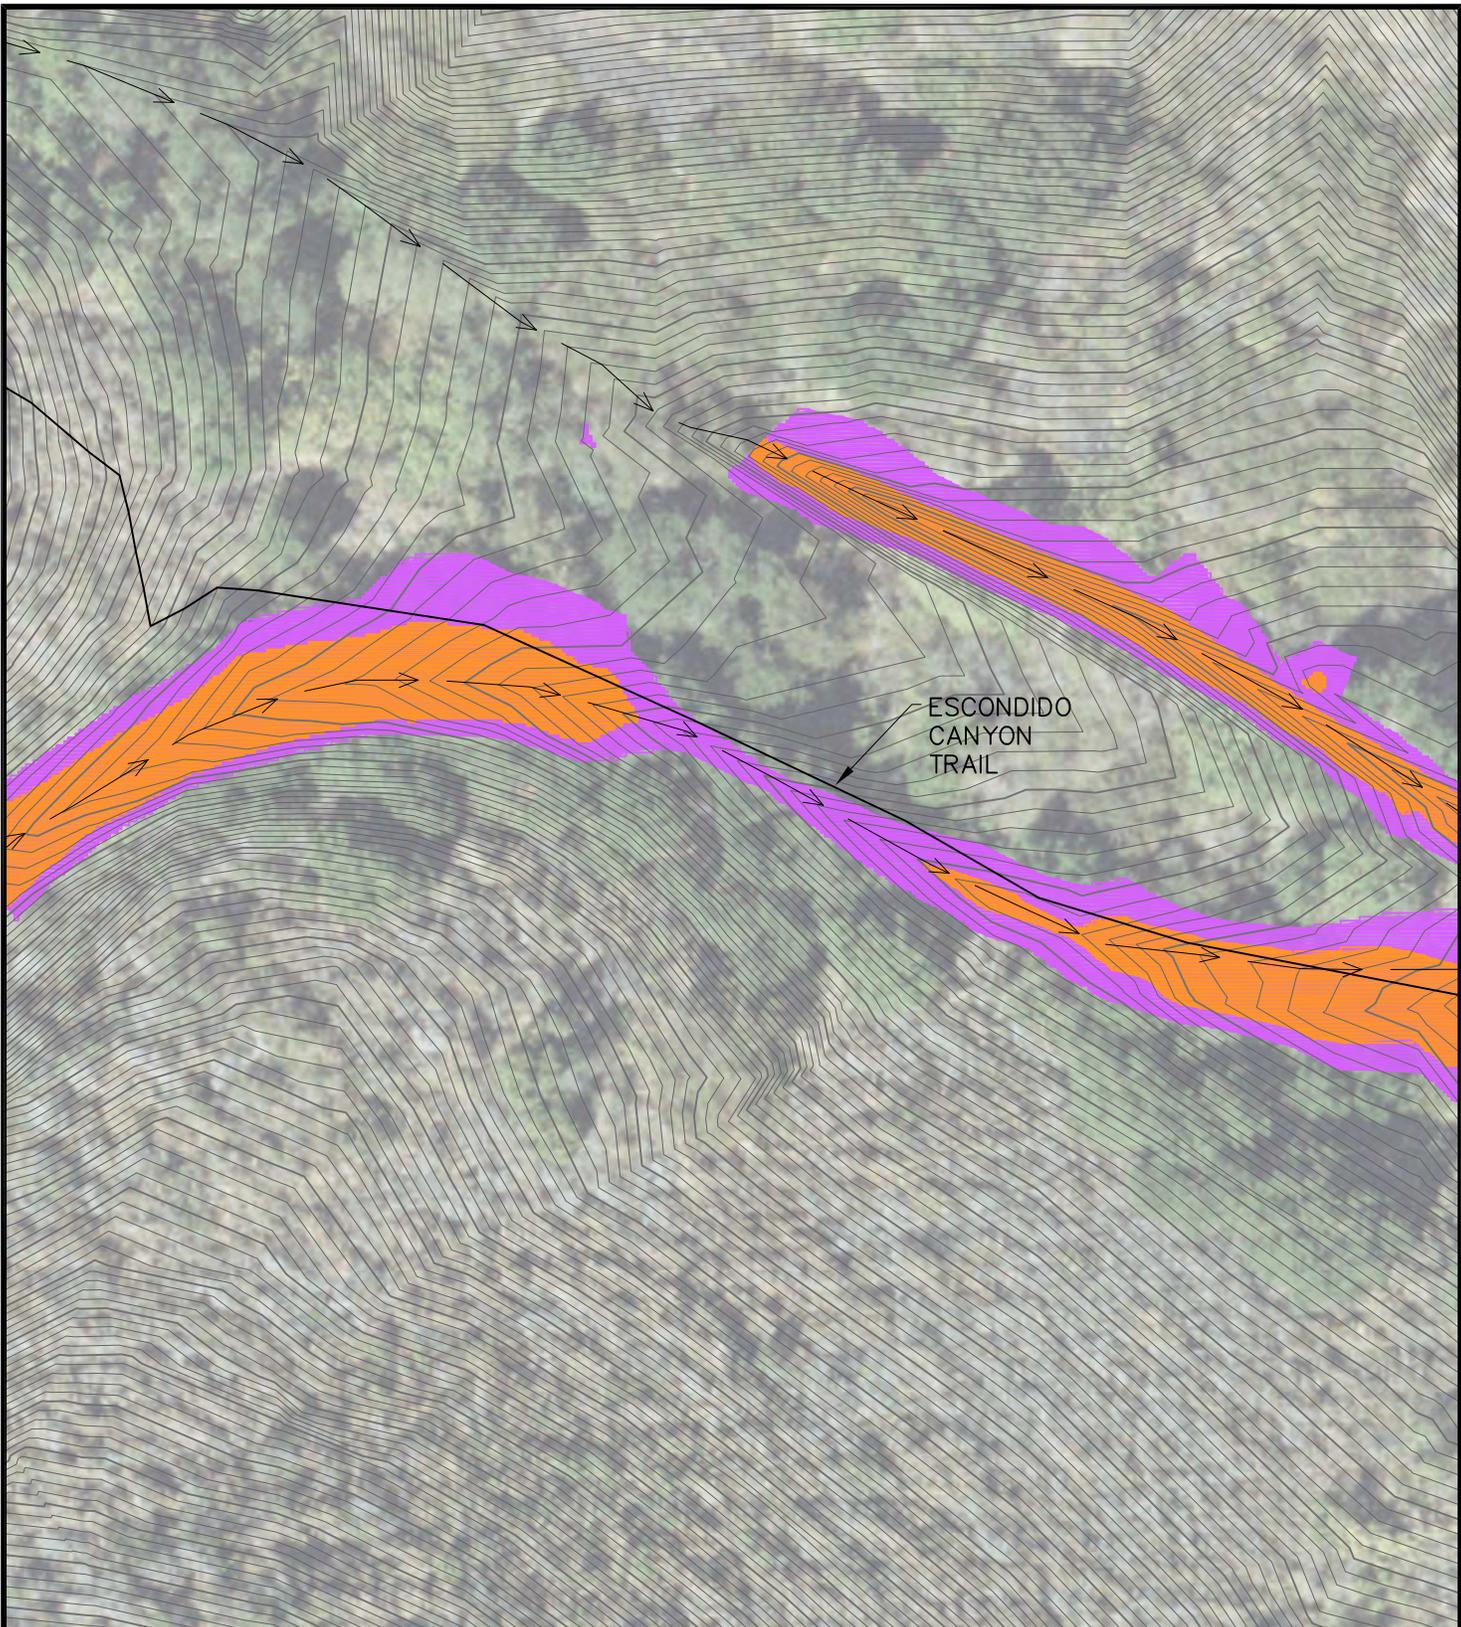
2-YEAR INUNDATION

50-YEAR INUNDATION
