**BURNED AND BULKED  
MALIBU BLUFFS  
CREEK CROSSING  
SANTA MONICA MOUNTAINS**  
MALIBU, CALIFORNIA

**EXHIBIT BB-23**

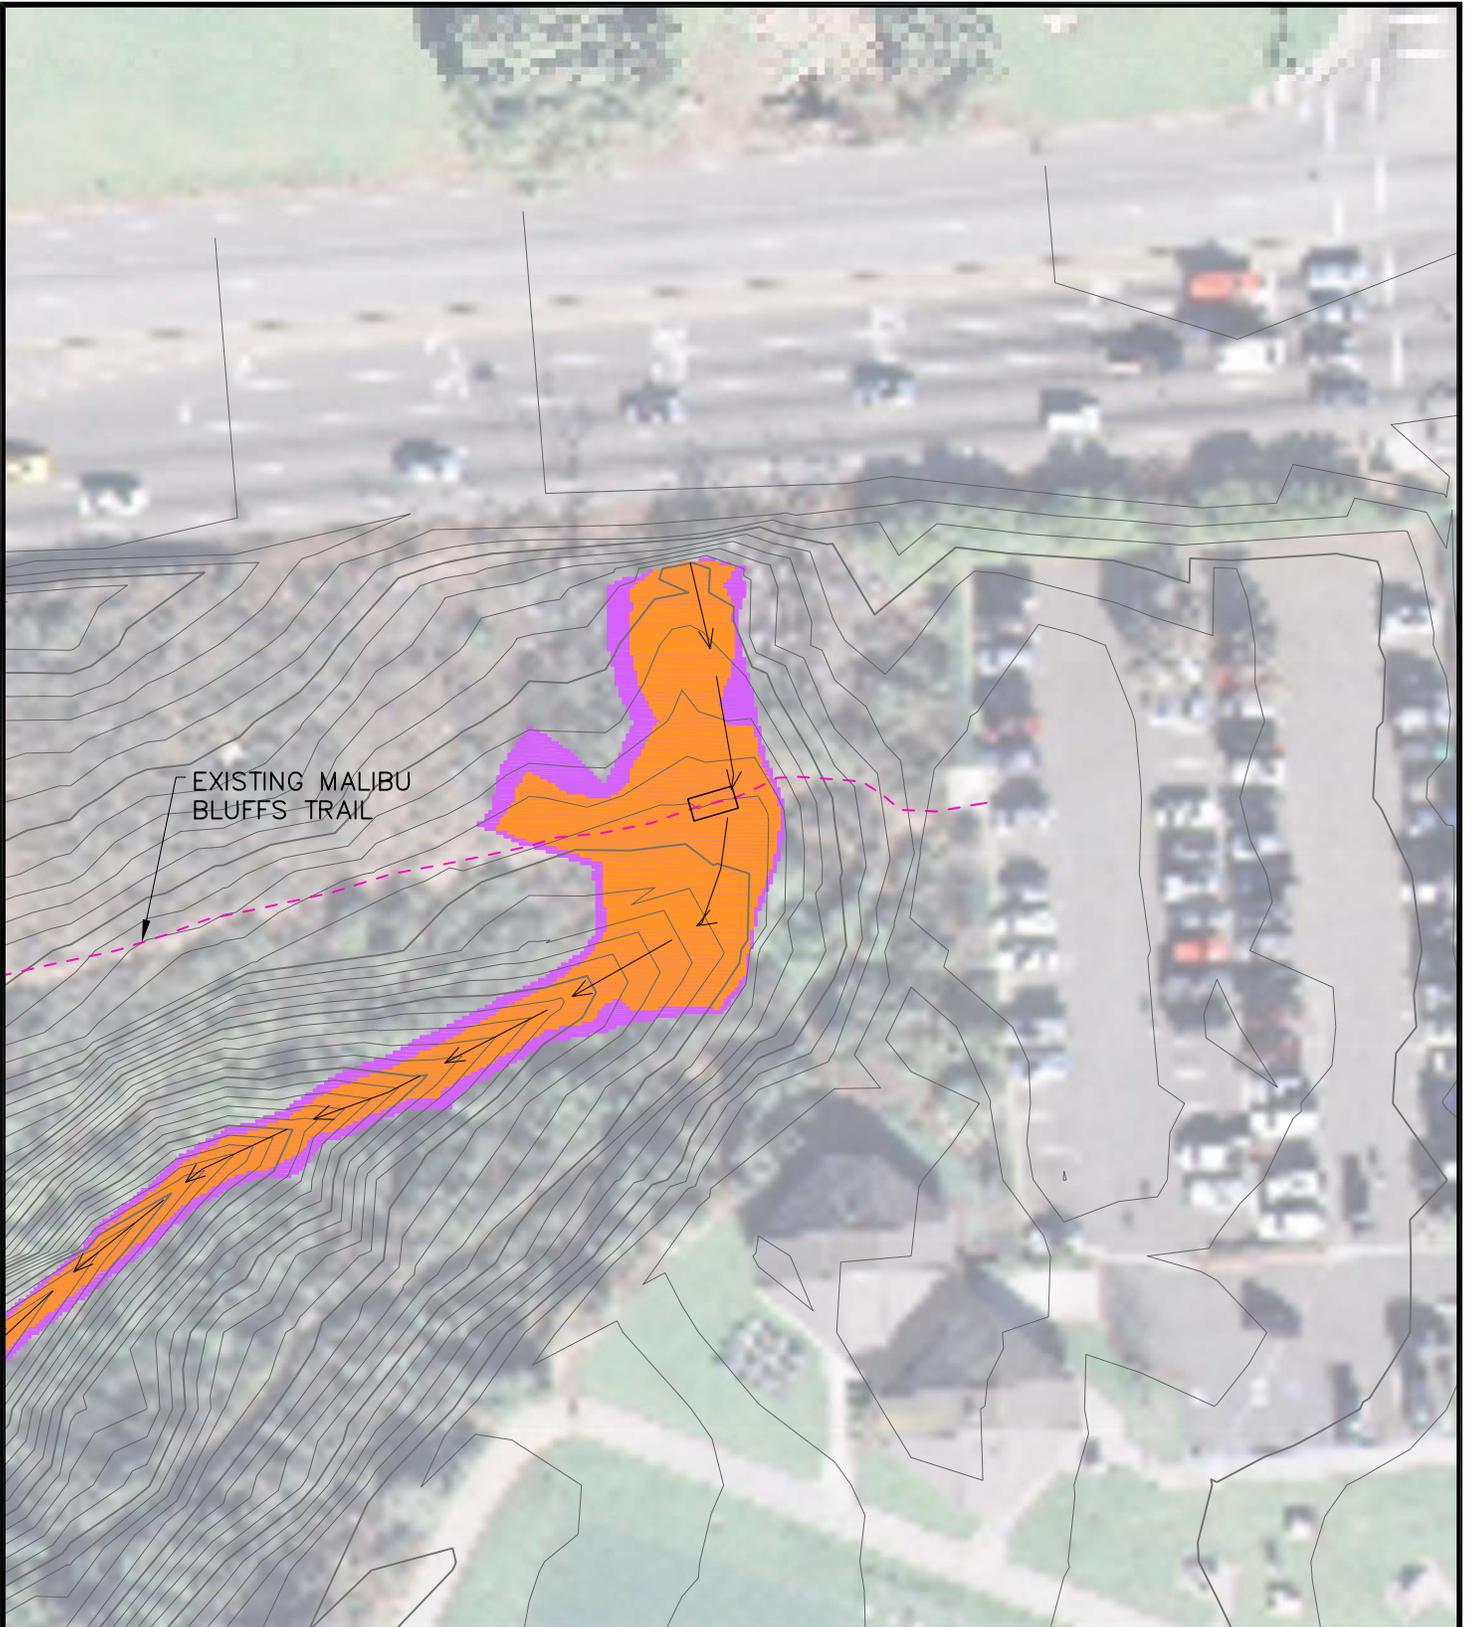
EXISTING MALIBU  
BLUFFS TRAIL

2-YEAR INUNDATION

50-YEAR INUNDATION
